Intel® 5100 Memory Controller Hub Chipset

Specification Update

May 2008

Revision 005US

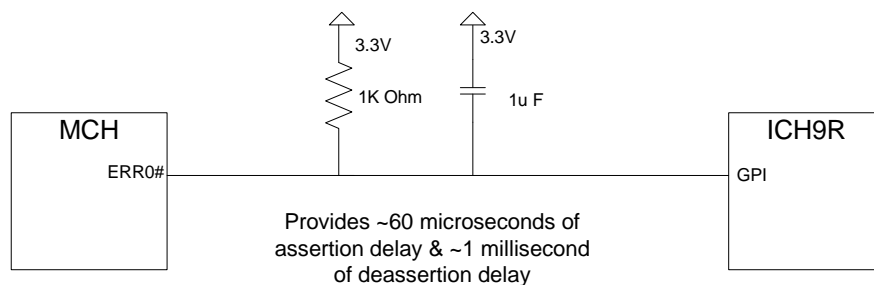
Problem: Any condition routed to MCH ERR[2:0]# output pins for SMI# escalation that would result in data poisoning on FSB will result in a CPU IERR# assertion due to race condition. The race condition exists between poisoned data presented to the FSB by the MCH and the uncorrectable error escalated to SMI# via ERR[2:0]# pins. If the CPU observes an SMI# assertion before the poisoned data is presented to the FSB, the CPU asserts MCERR# followed by IERR#. The CPU expects the SMI# assertion to occur at least ten BCLKs after the associated MCERR# assertion. Conditions that result in data poisoning on the FSB are uncorrectable memory ECC errors or poisoned TLPs received from any PCI Express* port.

Implication: CPU may assert IERR# and cause a system hang before the error may be logged in SMM.

2. Delay SMI# assertion by inserting a 60–150 µs delay on the ERR0# pin

- Two recommended circuit solutions (other solutions may be possible):

- Route errors that result in FSB data poisoning to the ERR0# pin (IO4, M1)
